Manhole Inspection Summary

Manhole # S63A__011MH

Inspection ☐ Is Incomplete Rating: **3) Fair**

Insp Date: **3/9/10 11:02 AM**

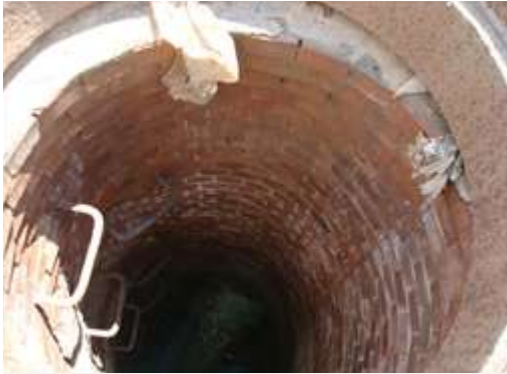
Defect 2

infiltration

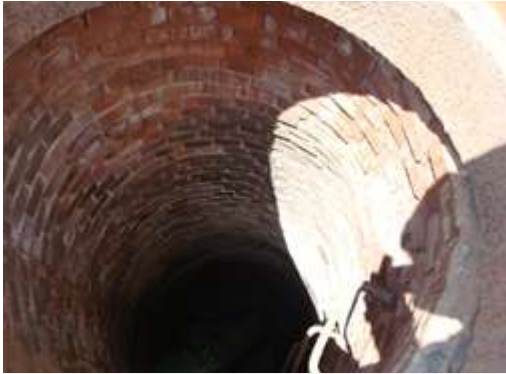
Defect 1

☒ **Leaks**

frame leaks

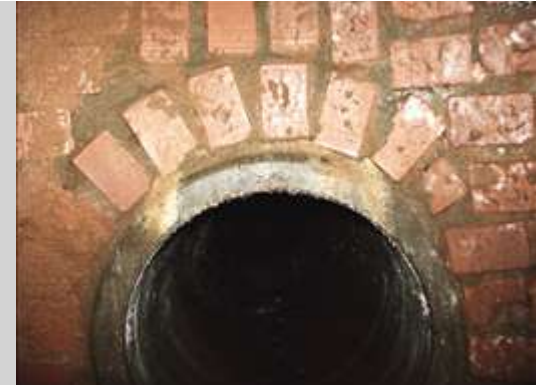
15 in. Circular Gravity Sewer
Pipe Out @ 12 O'Clock

Pipe Height: **19.2** (in.) Rod and Bar (Angled)
Pipe Material: **Clay** ☐ Pipe Lined
Invert Depth: **20.92** (ft.) Flow Characteristics: **Slow**
Deposits: ☒ None ☐ Mud ☐ Sludge ☐ Debris ☐ Grease
Silt Depth: (in.) Deposits Extent:
Infiltration: **None** Pipe Seal Cond: **Sound**

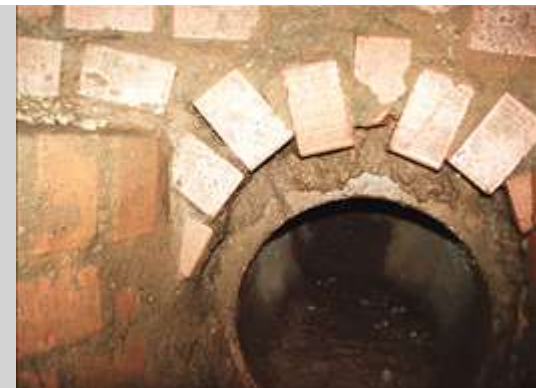
15 in. Circular Gravity Sewer
Pipe In @ 4 O'Clock

Pipe Height: **19.2** (in.) Rod and Bar (Angled)
Pipe Material: **Clay** ☐ Pipe Lined
Invert Depth: **17.58** (ft.) Flow Characteristics: **Slow**
Deposits: ☒ None ☐ Mud ☐ Sludge ☐ Debris ☐ Grease
Silt Depth: (in.) Deposits Extent:
Infiltration: **None** Pipe Seal Cond: **Sound**

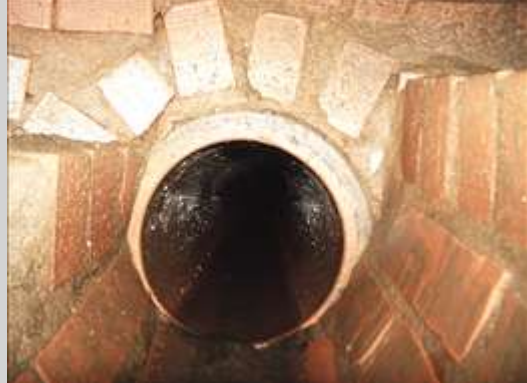
8 in. Circular Gravity Sewer
Pipe In @ 6 O'Clock

Pipe Height: **9.6** (in.) Rod and Bar (Angled)

Pipe Material: **Clay** ☐ Pipe Lined

Invert Depth: **19.83** (ft.) Flow Characteristics: **Slow**

Infiltration: **None** Pipe Seal Cond: **Sound**
